# PIONEER HALL

KETCHIKAN ALASKA

HISTORIC BUILDING ASSESSMENT

Prepared by  
PIONEERS OF ALASKA, KETCHIKAN  
HISTORIC KETCHIKAN, INC. &  
WELSH WHITELEY ARCHITECTS

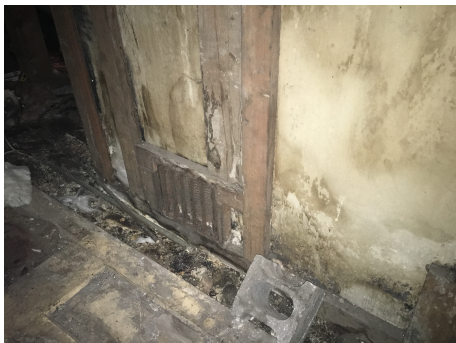
The bedrock is wet in many locations, and water gathering at the low point around the boiler room has rotted the bottom of the wood stud walls at the

*Mold growth in the boiler room area*

boiler room, and encouraged mold growth on the gypsum wall board. Foundation work should include an attempt to find and block the sources of water infiltration. If this proves impossible, a collection pit and sump pump to manage water, and an exhaust fan or fans controlled by a humidistat, are advised to reduce the moisture levels in the crawl space.

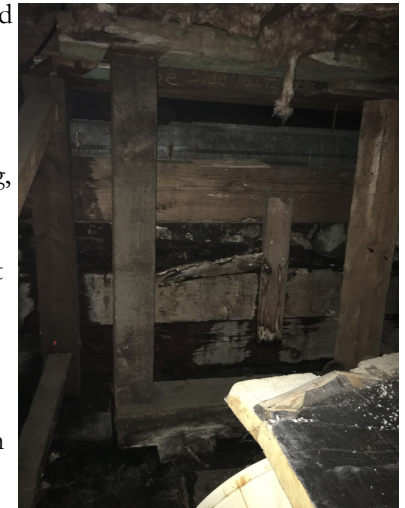
The above-grade skirting is decaying along the bottom edge at many locations, due to direct contact with bedrock, and backsplash off the surrounding grade. There are areas on the southeast wall of the crawlspace, where the skirting appears sound but the posts are rotting. Daylight is visible at intermittent locations under the skirting and just underneath the floor structure. Some of these gaps have been filled with expanding foam. Ideally a continuous, reinforced concrete footing would be poured to support the floor structure at areas where the floor is close to grade, or to raise the bottom edge of the skirting at areas with more clearance. To reduce the cost of repairs, concrete could be limited to select shear wall locations and areas where moisture seeps in, and the remaining skirting could terminate at new preservative-treated mudsills. If foundation work is completed in multiple phases, the above-grade skirting repair is lower priority than other repairs noted.

*Deterioration of skirting & posts*

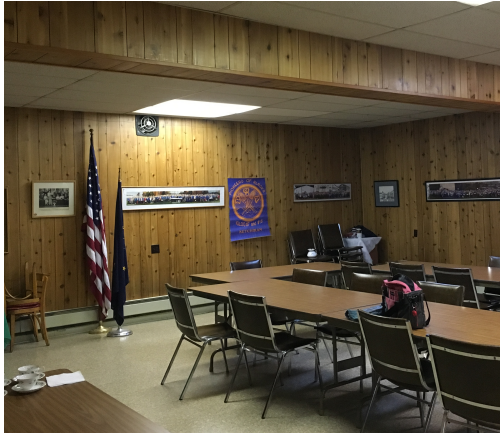
*Support beam in Hall for 2nd Floor*

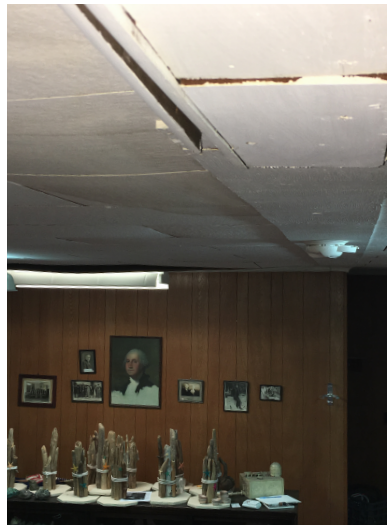
**Second Floor Structure:** Structure supporting the Meeting Room is clearly undersized based on the springy, noticeably sagging floor in that area. The central support beam spans northwest-southeast below-ceiling in the Hall below, but the size of the beam is obscured by paneling. The beam should be replaced or reinforced to accommodate the structural loads prescribed for the use of the building.

*Sag in Meeting Room ceiling*

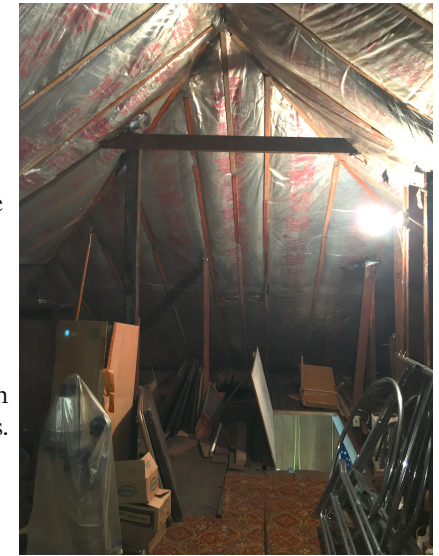
*Rafter configuration in attic*

Along with the plywood mentioned above, rafter-to-rafter straps across roof ridge and hips, and rafter-to-wall plate clips or straps should be installed when the building is re-roofed. Roof replacement should be anticipated early in the restoration program.

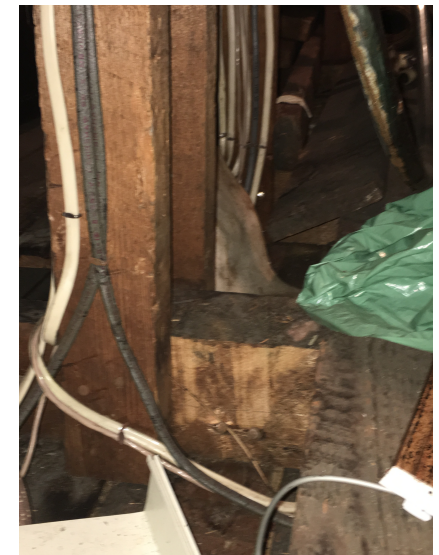
*Beam/stud configuration in attic*

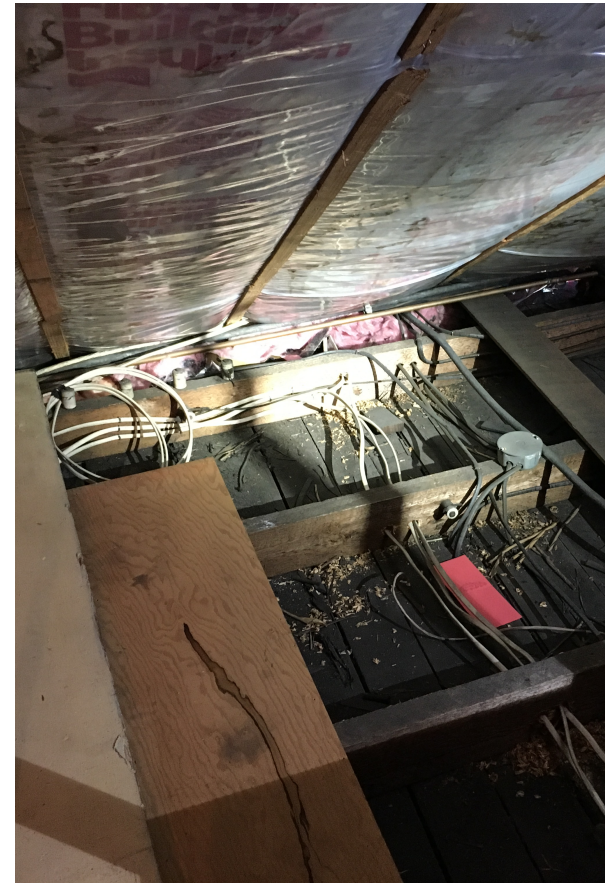
Over the years additional electrical panels, circuits and wiring have been added, so there is a wide array of wiring methods ranging from Romex, knob and tube, wiring with cloth insulation, and conduit and wire systems. There are many NEC code violations which need to be addressed when the building is renovated.

*Over its 121 years, many changes have naturally been made to the Pioneer Hall electrical system. Most of the initial knob and tube wiring has been replaced but there remains a considerable amount of ungrounded wiring and receptacles. This view of the attic wiring shows many different types of wiring methods.*

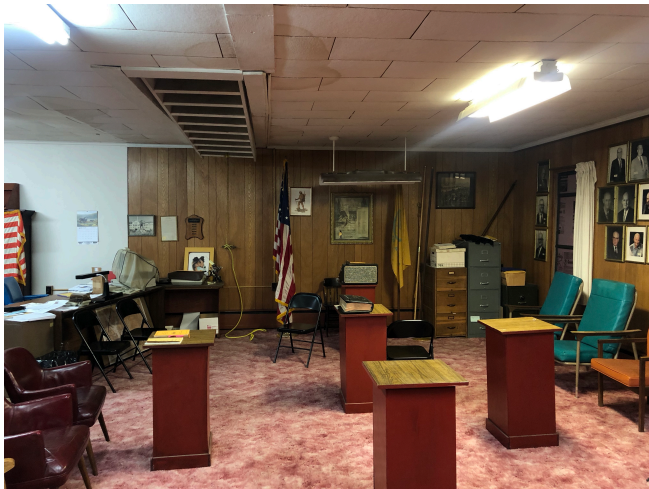
In general, most of the existing system uses fixtures that are old and should be replaced with new, energy efficient light fixtures. Some fixtures may be reused in the renovation work; this will be determined during the design phase; fixtures that are reused may require refurbishing and relamping.

*Fluorescent lighting fixtures in the Meeting Room*

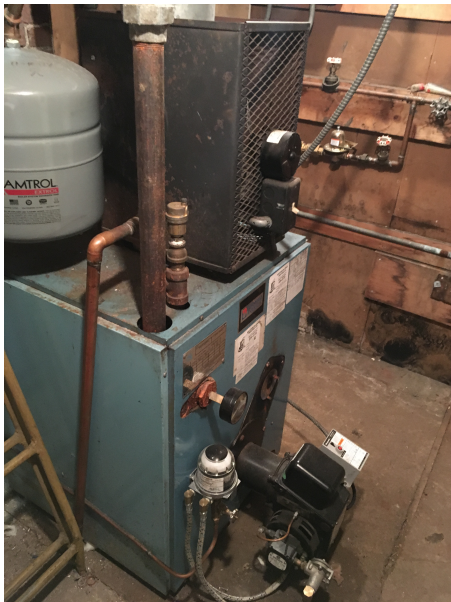
**Historic Mechanical Systems:** Historical research indicates the building was initially heated with several wood, coal, or oil-fired stoves vented with metal flues. The flues were replaced with brick chimneys in 1902, after a fire in the building. At some point individual stoves were replaced with a hot water or steam boiler; sections of cast-iron radiators and a discarded boiler are located in the crawl space. The discarded boiler was not closely examined due to the possible asbestos-containing material it is wrapped with, but appears to date to the 1920s.

*Existing boiler in crawl space*

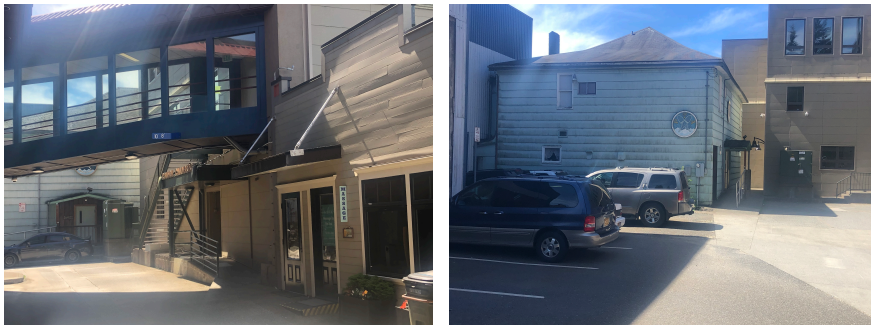
*The historic Pioneer Way is now dominated by vehicular access. Improvements should include demarcation of the walkway and attention to pedestrian amenities.*
