HISTORIC DOWNTOWN KETCHIKAN A RESTORATION HANDBOOK

Prepared for the
Ketchikan Historic Commission
April, 1986

Author: Douglas M. Campbell

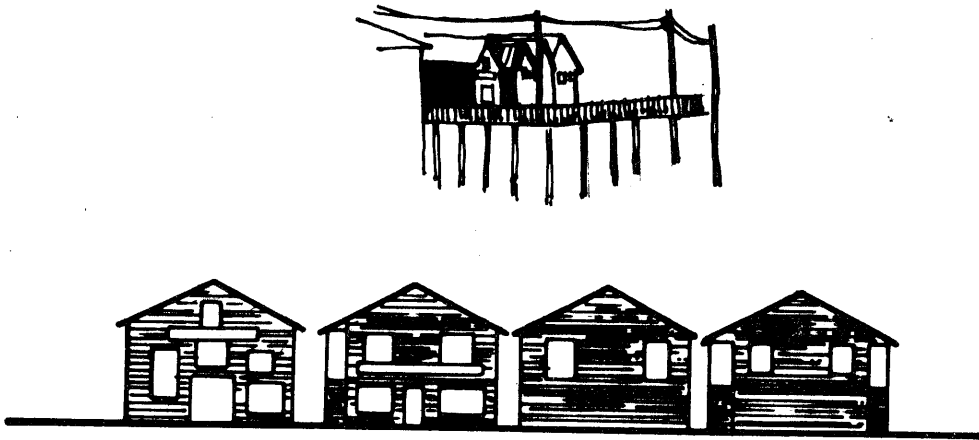
FIGURE 20

130 Thomas - Union Machine Shop

Built prior to 1920 and moved to this site in 1935, the building retains its original appearance. Significant elements are its wide window (see Figure 12), door, and corner trim; multi-pane windows; bevel tongue and groove siding; roof form and pitch; and exposed rafter ends. Its form and mass fit the existing historic street appearance. It has been excellently maintained and is in sound condition.

Recommendations:

1. Retain present facade appearance.
2. Removed corrugated metal siding on south wall and restore or replace original bevel siding.
3. Continue excellent maintenance.

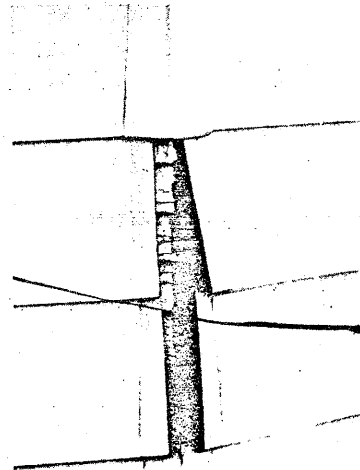
Damaged aluminum siding allows water to enter behind the siding causing the frame structure to rot.

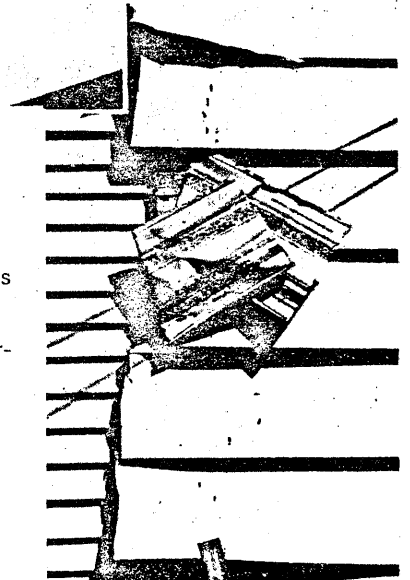
Aluminum siding strips covering three clapboards, totally changing the building's character. This aluminum siding is easily bent and damaged.

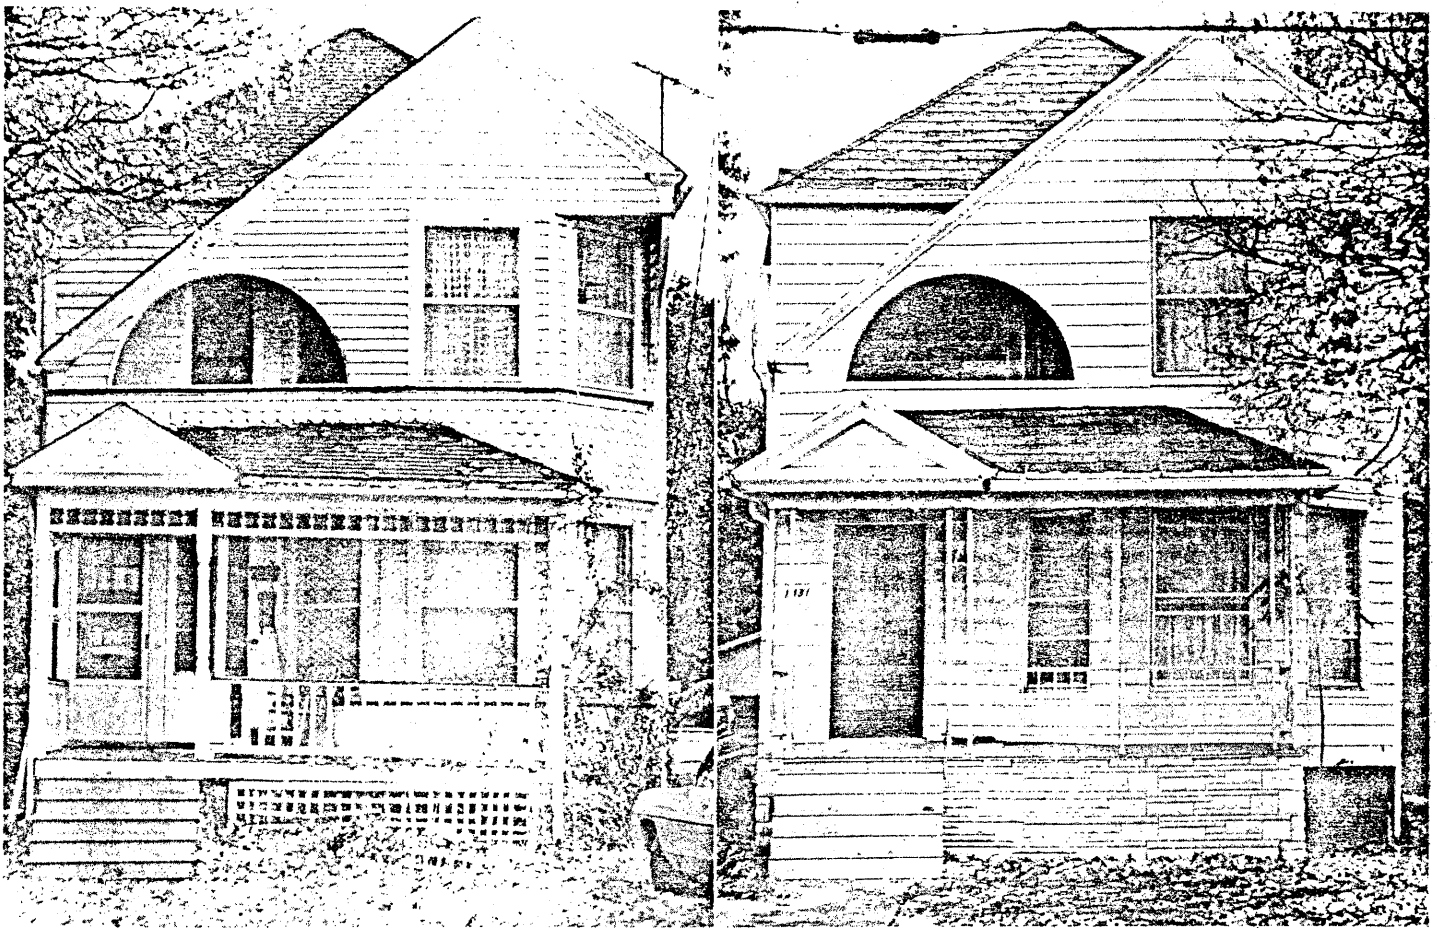
These houses were identical until the one on the right was covered with aluminum siding. Though the houses do not possess high architectural significance, they did have character and visual interest. The house on the right lost its character and visual interest when the variety of textures and details were covered with aluminum siding.

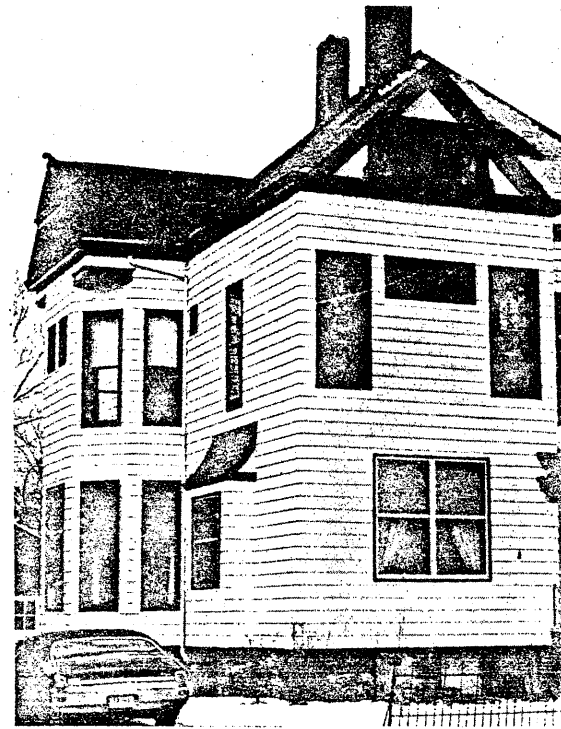
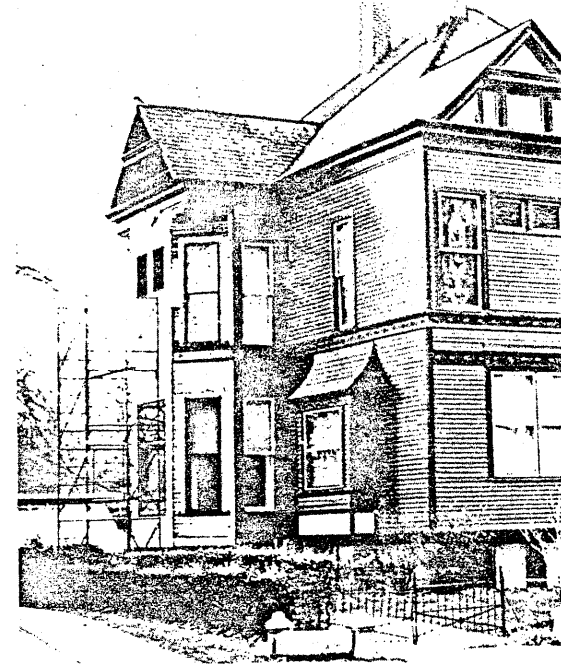
Above top: Covered with aluminum siding, this 1889 District lacked detail and had a flat monotone appearance.

Above bottom: The same house during a restoration historic preservation grant-in-aid administered by the department. The synthetic siding is being removed, rotten or missing porches are being restored, and the building is being restored with a variety of textures, details, and colors.

To restore the building, the owner is replacing damaged or deteriorated wood siding and trim, reconstructing missing trim and details, filling nail holes and cracks, and scraping all loose paint. He is then sanding, priming, and painting the siding with colors that match the original. This project also involves restoration of the house's porches, which had been altered when the aluminum siding was installed. The porches' original wood columns and railings were replaced with wrought iron, altering the original design and appearance of the house. Those wrought iron fixtures appear too light and delicate to carry the roof's weight, and they may not be structurally sound. The sagging roof provided evidence that the supporting system was failing. The inappropriate wrought iron columns and railings will be replaced with columns and railings matching the original.

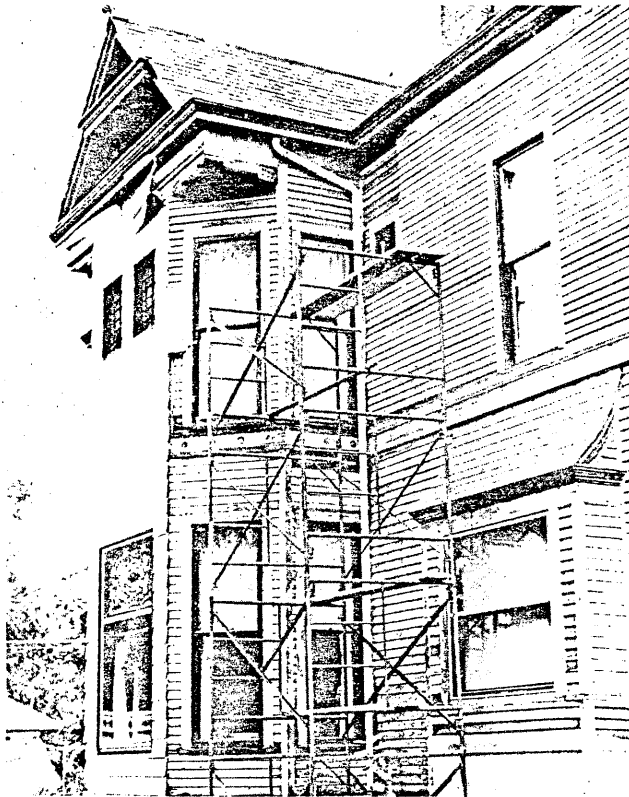
Above: As the aluminum siding was removed, it became evident that water had been seeping behind the siding and that the clapboards beneath had rotted. As a result, all clapboards above the second-floor windows had to be replaced. Water had also collected at the raised banding below the second floor windows, rotting the clapboards there. Note the shadowlines of the bull's-eye details that were removed to accommodate the siding.

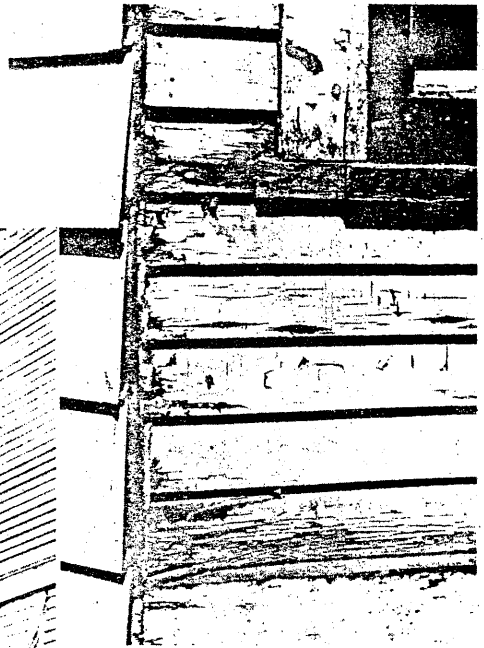
Above: Each strip of aluminum siding covered more than two original clapboards, changing the original character of the house. This photo also shows how the windowsills had been cut away to accommodate the synthetic siding.

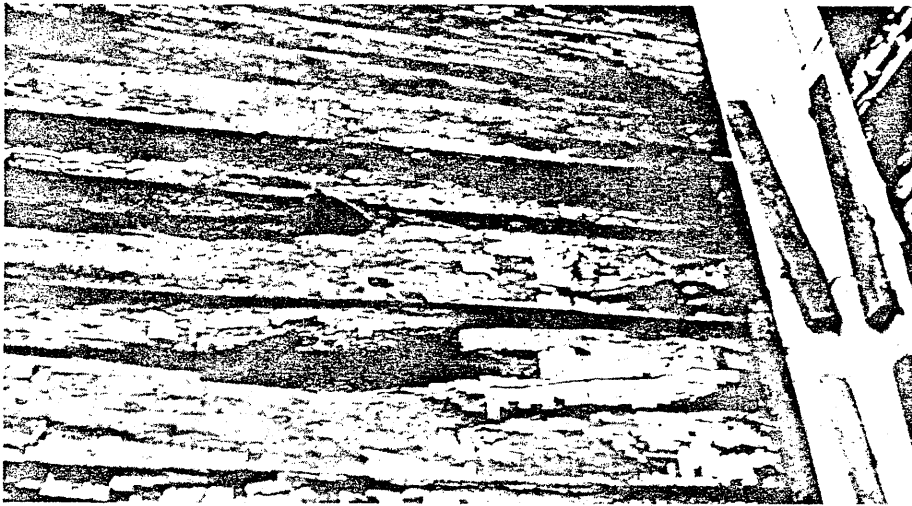
Above: The areas where water had been trapped beneath the synthetic siding showed severe deterioration. In this case, even the studs had rotted and the interior plaster was beginning to fail.

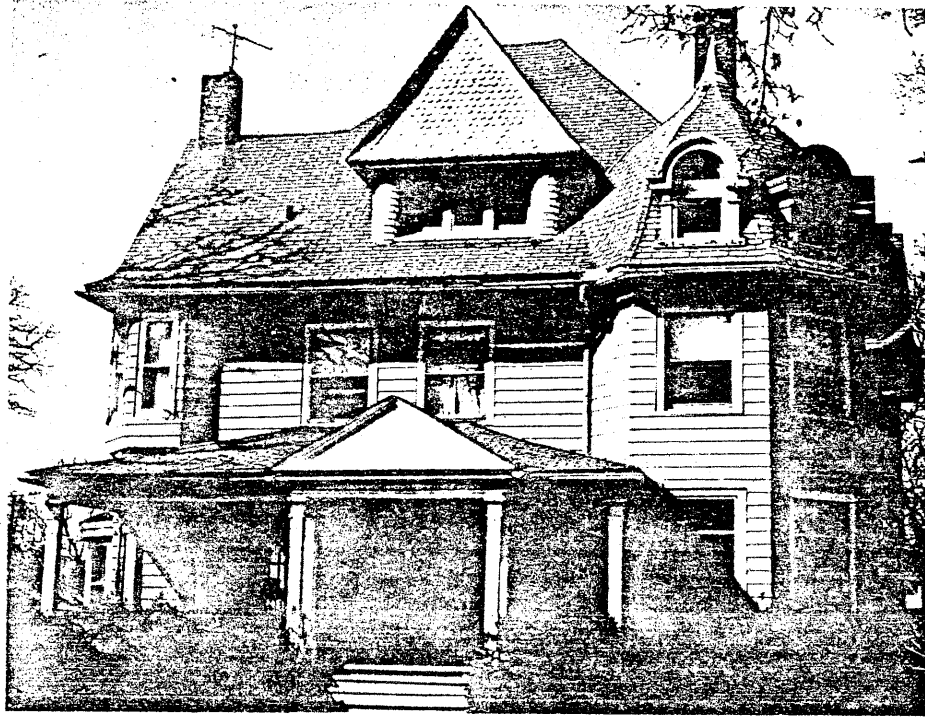
Left: This modified Queen Anne style house in Oak Park was covered with aluminum siding twenty years ago. The siding not only changed the proportions of the building, it also became dull and faded.

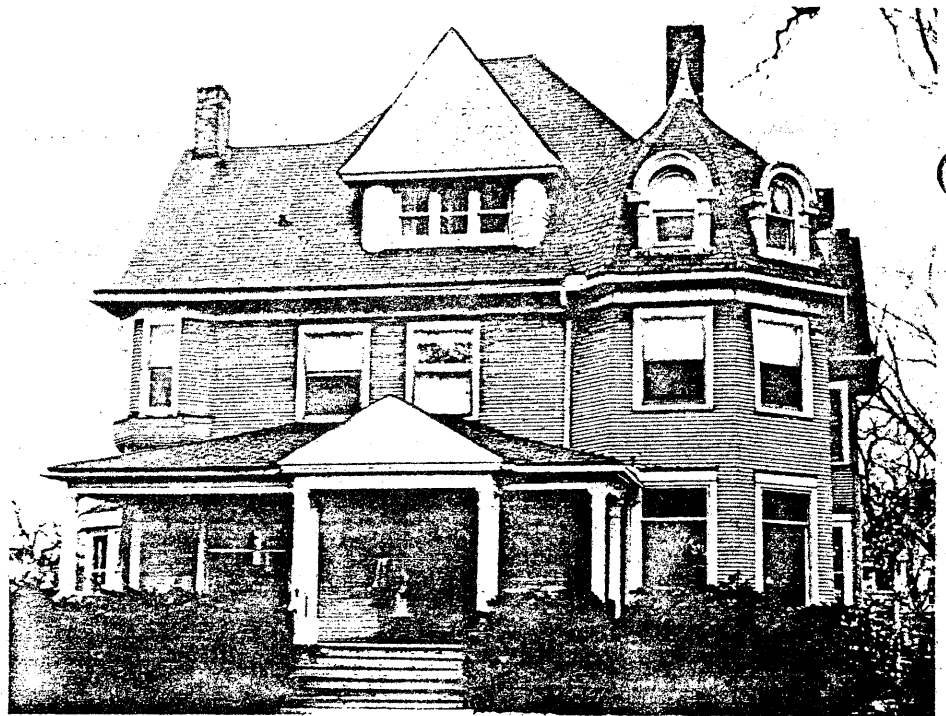
Below: During the restoration project, the aluminum siding was removed, exposing missing or damaged clapboards and trim. Note the delicate bowing of the turret, which was obscured by the aluminum siding. The wood elements will be repaired as necessary, and the house will be painted.

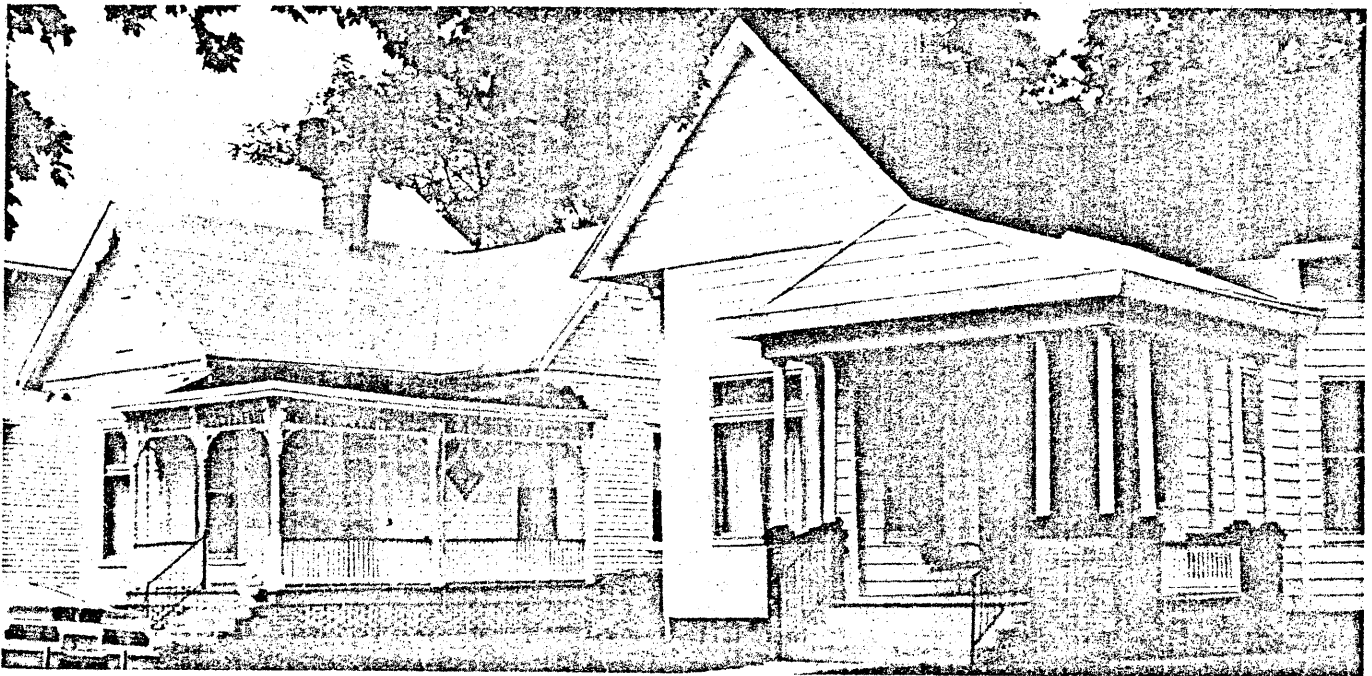
Two originally similar houses. When aluminum was installed on the house on the right, the barge boards, scrollwork, columns and railings were removed. The distinctive shingled gable and attic vent were covered, further compromising the building's architectural integrity.
