# PIONEER HALL

KETCHIKAN ALASKA

HISTORIC BUILDING ASSESSMENT

Prepared by  
PIONEERS OF ALASKA, KETCHIKAN  
HISTORIC KETCHIKAN, INC. &  
WELSH WHITELEY ARCHITECTS

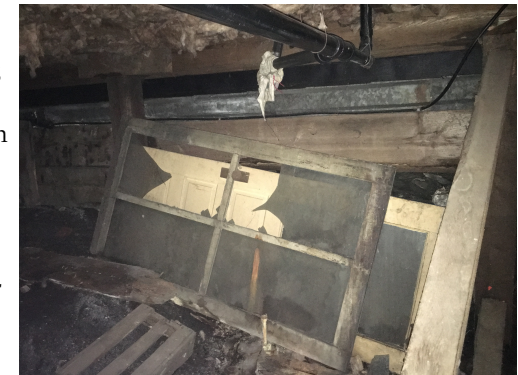
*A photo taken by the survey team of an historic storm sash and door found in the crawl space provides insight to original historic features.*

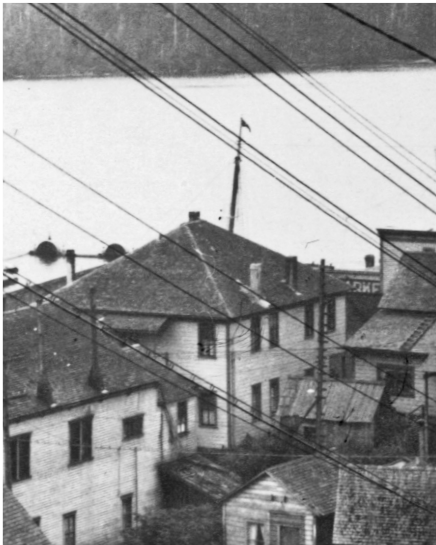
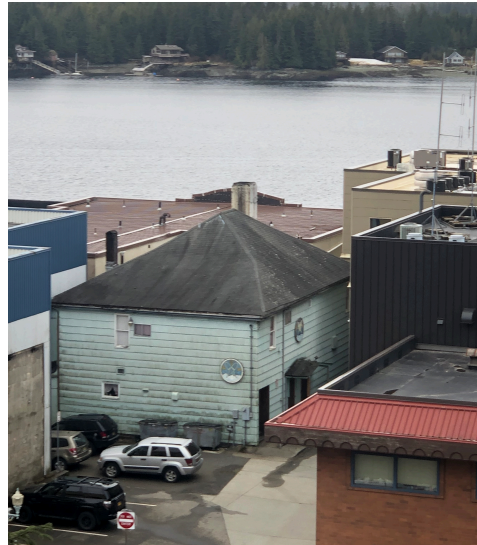
These comparative photos document the changes to the roof form and to the Pioneer Way and Main Street facades. Most noteworthy is the removal or covering over of the distinctive double-hung windows and the modifications to siding and trim.

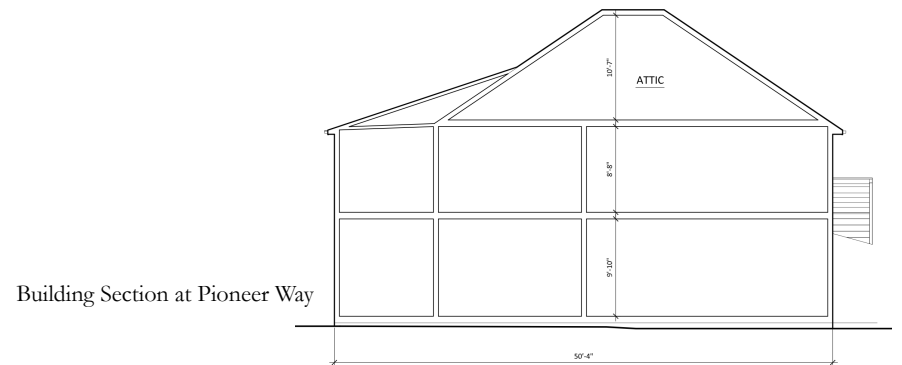
Building Section at Pioneer Way

The primary hip roof is a 8:12 pitch with 3-tab roofing shingles. The addition toward Main Street in 1947 is a 4:12 pitch. The roof structural assembly appears sound and dry. Its outermost layer began as cedar shingle and, according to research of photos, had at least several iterations of cedar shingle roofs. While three brick chimneys penetrated the roof in the building's earliest days, only one remains on the southeast side of the building. The small 4:12 roof over the entry is also 3-tab shingles.

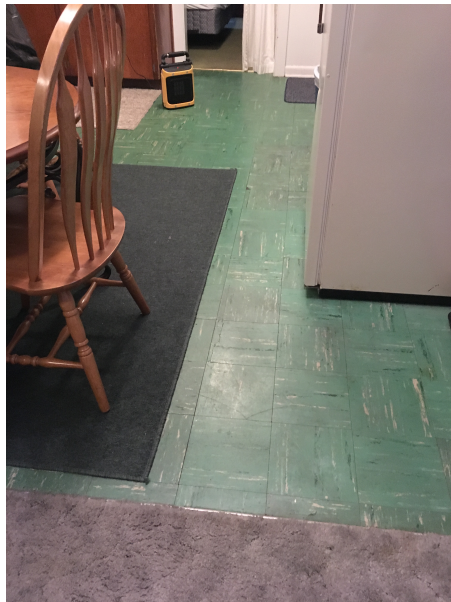
The wrapping material on the abandoned boiler in the crawl space and the 9"x9" floor tiles visible in the second floor apartment were noted during examination of the building. A certified asbestos abatement contractor will take samples of these and other materials. If asbestos is found, it will need to be removed using methods described in an approved abatement plan.

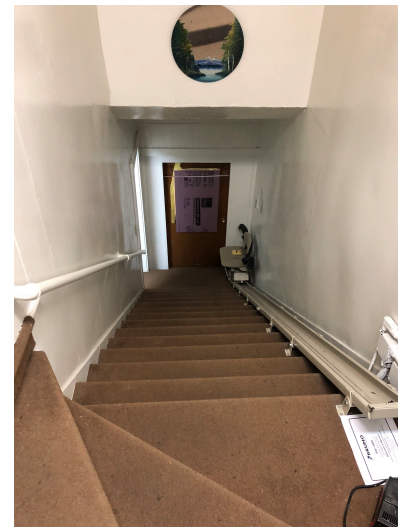
In identifying accessibility modifications, the assessment team examined the existing access and the specifics of improvements needed. Primary access to the building is provided by the ramped entry off Pioneer Way. Within the building, there is stair access to the second accompanied with a stair lift. The stair does not meet code (as described in the Fire and Life Safety section) and should be replaced as part of any substantial work on the building. This will help prevent injury to Pioneer members and reduce the organization’s exposure to liability if someone were to fall.

*A photo taken by the survey team of the primary access from the main floor to the second floor meeting room and apartment. A stair lift serves as the only means of accessibility for Pioneer members with limited mobility.*

- The interior stairway should be replaced as part of remodel work, due to immediate safety concerns. The exterior stairway should be further evaluated and improved as part of future design work.

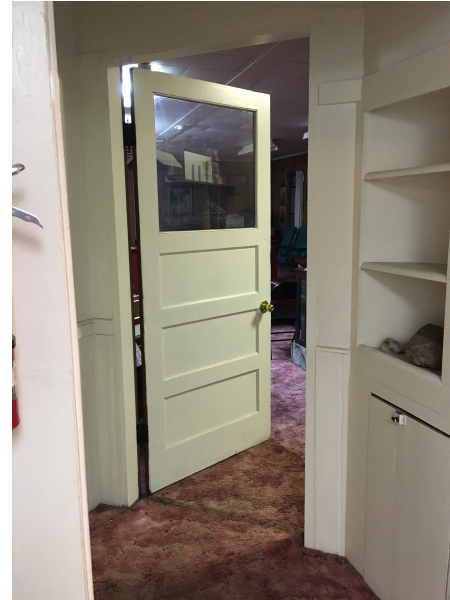
*One of several remaining interior doors*

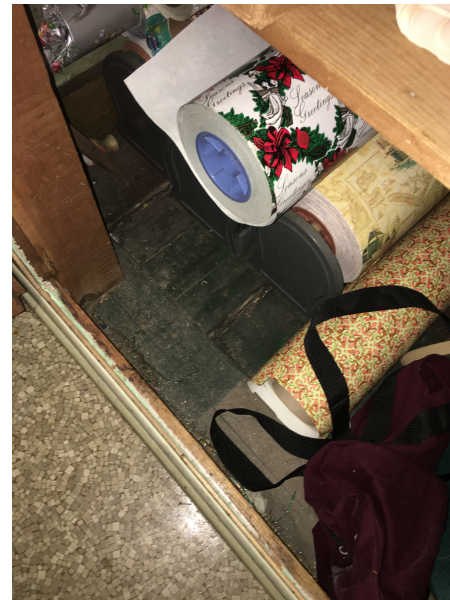
The above photo shows the original plank flooring, the wainscoting and original ceiling height of that space. While the wainscoting is gone and a dropped ceiling reduced the ceiling height, the plank flooring may remain under present sheet vinyl and carpet surfaces. The photo at the right shows remaining plank flooring inside the Meeting Hall closet—adjacent to more recent sheet vinyl. Other remnants exist. The photo on the far right shows the original wall panels still in place in the same Meeting Hall closet.

*Meeting Hall closet floor*

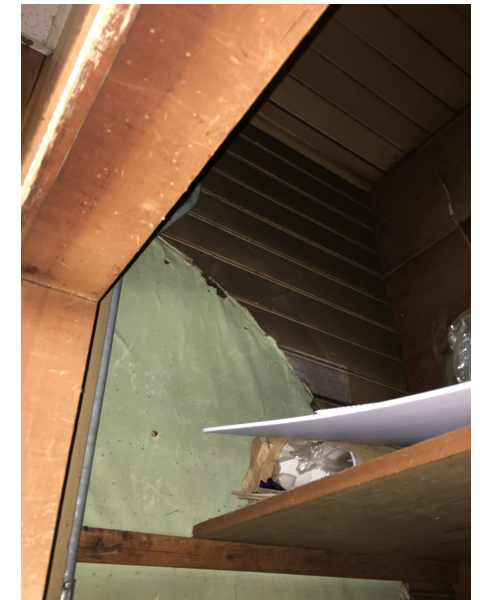
*Meeting Hall closet wall panels*
